Lower Neuse Basin Association Nov, 1st , 2018

*Algal Bloom Assessment Program
Department of Environmental Quality
Division of Water Resources*

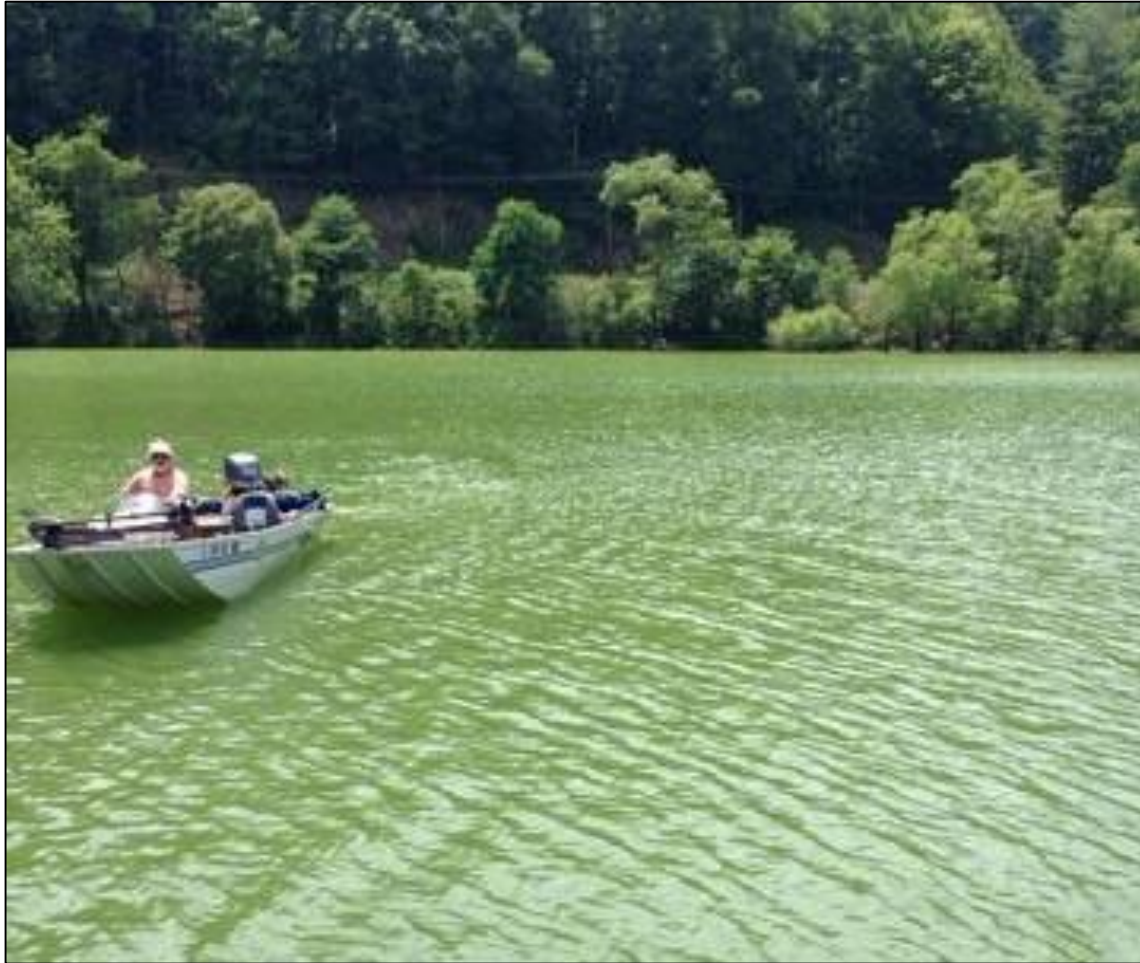
Bright green discolored water

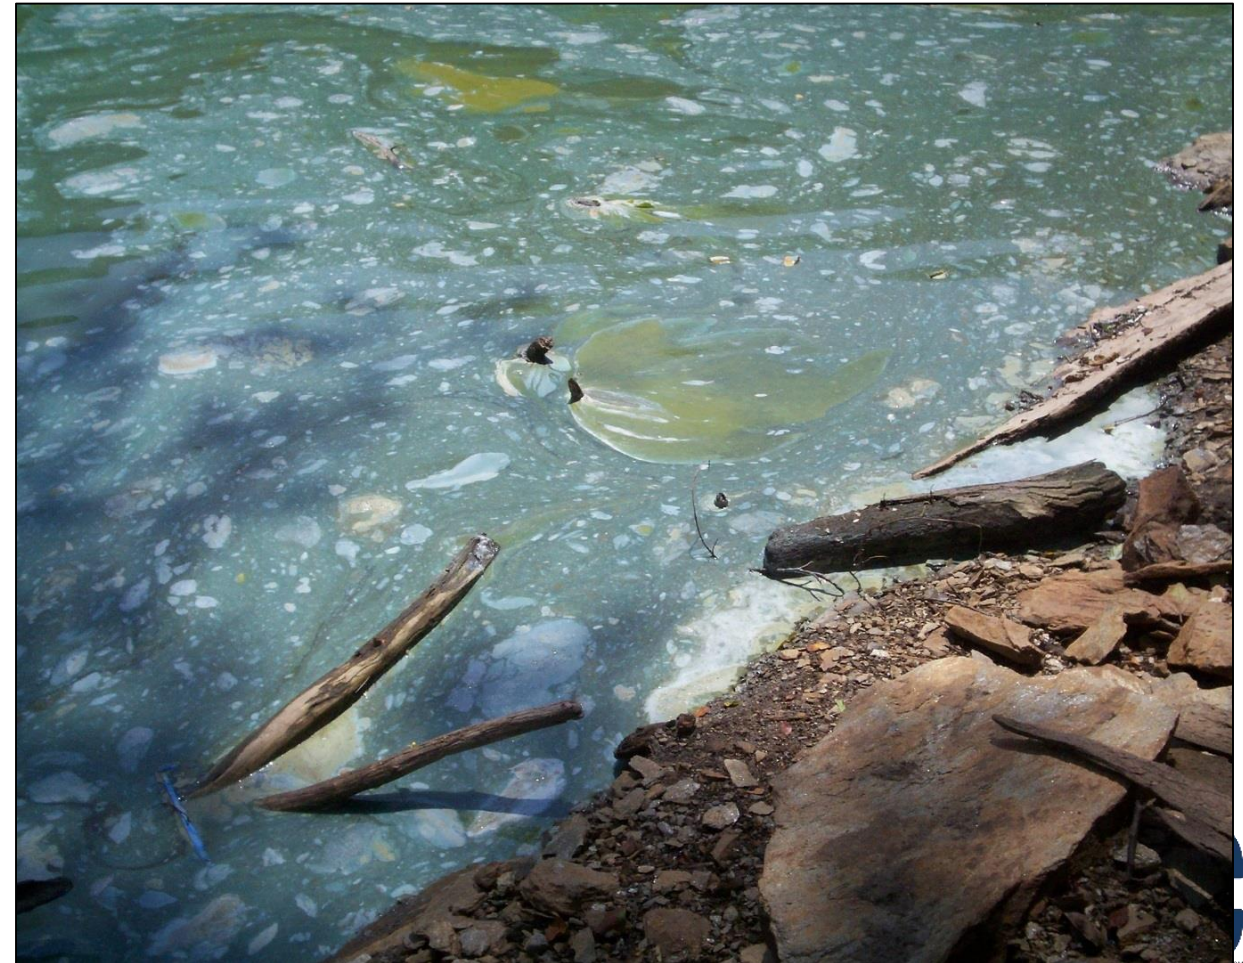
Blueish white decomposing mess

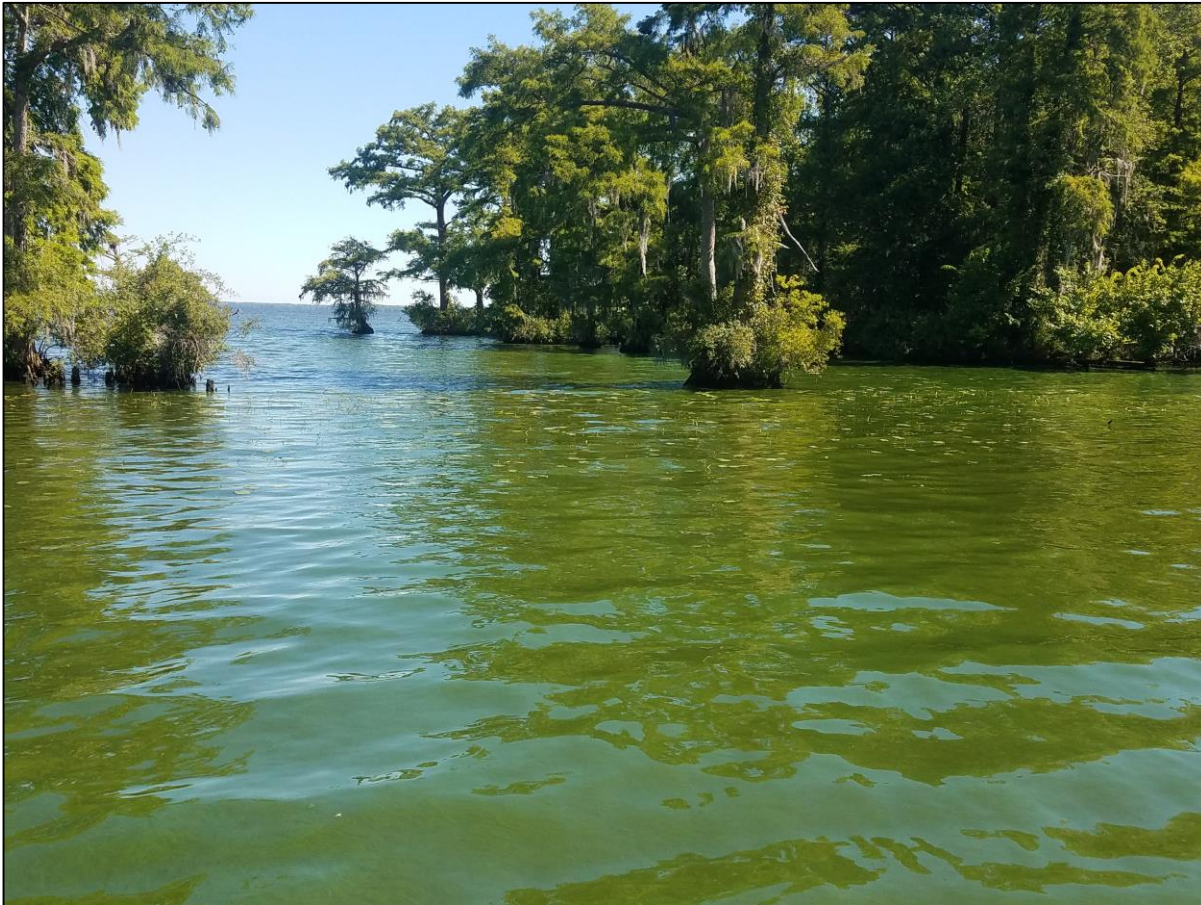
Bright green discolored water

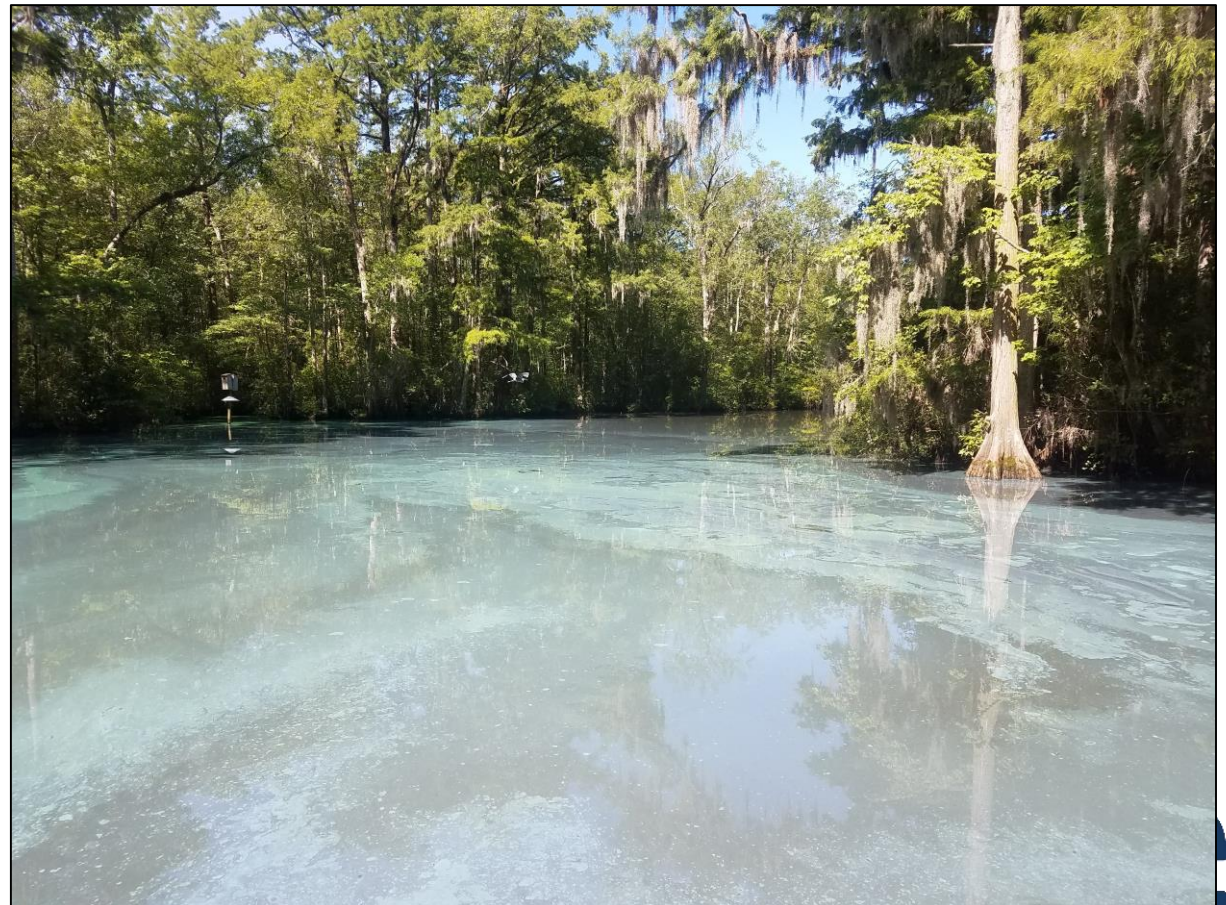
Blueish white decomposing mess

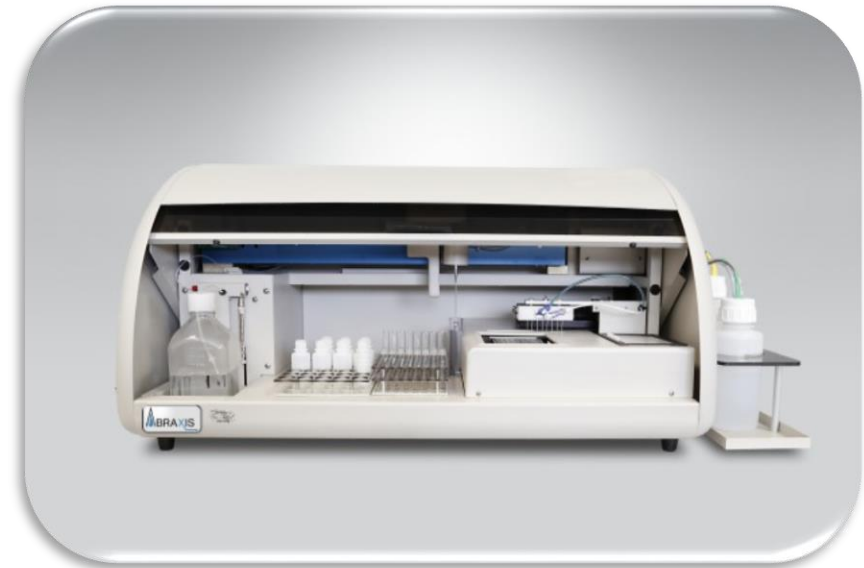
- Field Staff/Regional Office (2016)
 - Abraxis cyanotoxin test strips
 - Rapid assessment
 - Field or office use
 - Limited results (no verification procedures)
- Water Sciences Section Chemistry Laboratory (2017)
 - Abraxis Cyanotoxin Automated Assay System
 - ELISA instrument
 - Quality assurance and Quality Control procedures
- Special Studies (2018)
 - Draft cyanotoxin sampling procedures
 - Test strips vs ELISA
 - Basinwide Monitoring Program
 - Drinking water supplies
 - Emerging compounds (contaminants)
 - Comparison testing/Laboratory variance
